Final Wicomico River Watershed Management Plan - Updated

April 2014

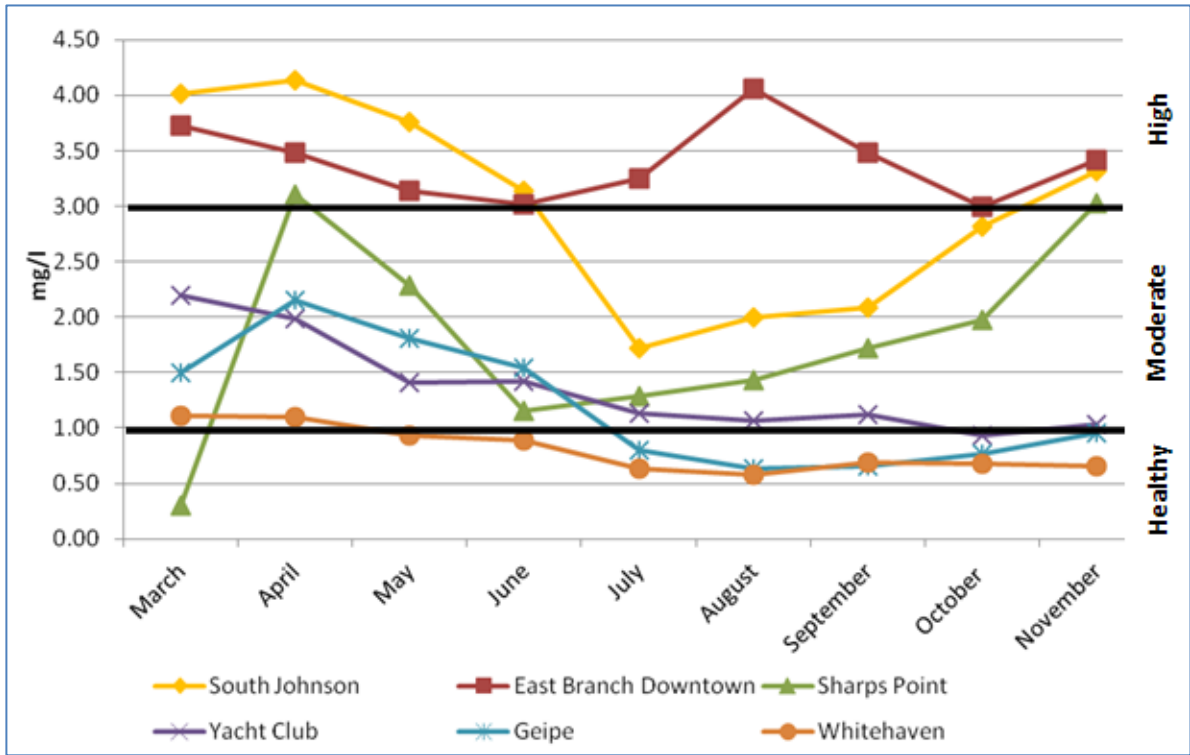
Figure 2. 4. Average Monthly Total Nitrogen Concentration (mg/l)

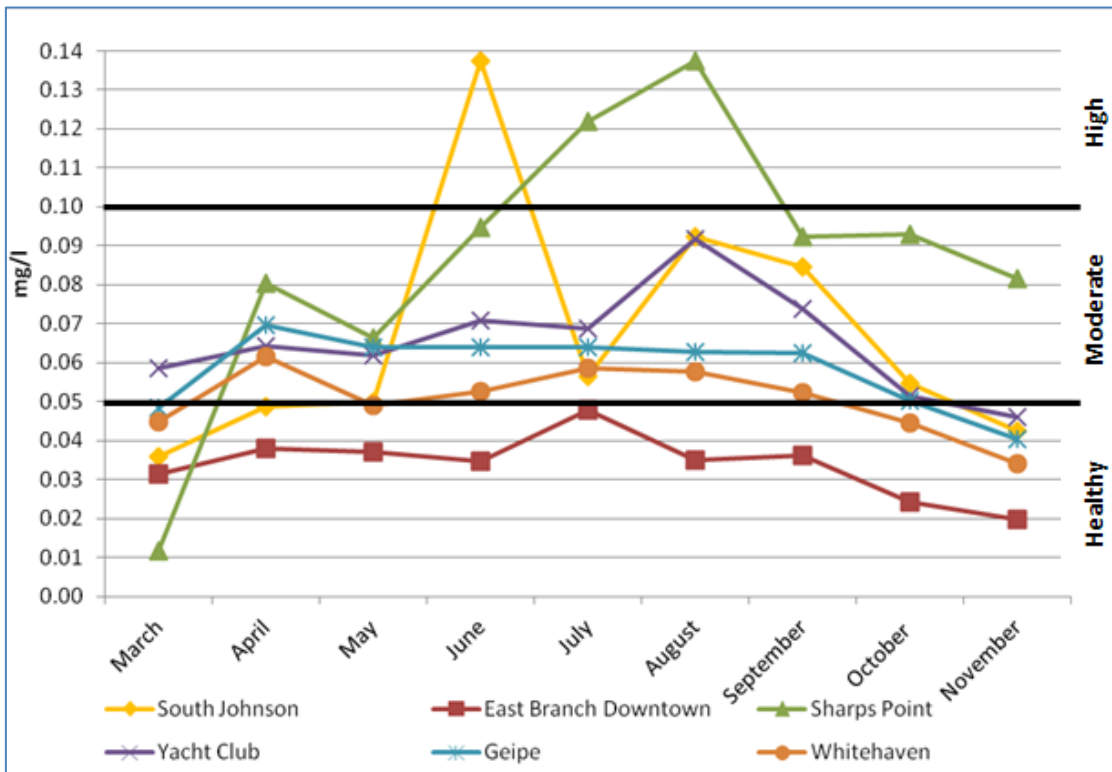
Figure 2. 5. Average Monthly Total Phosphorus Concentration (mg/l)

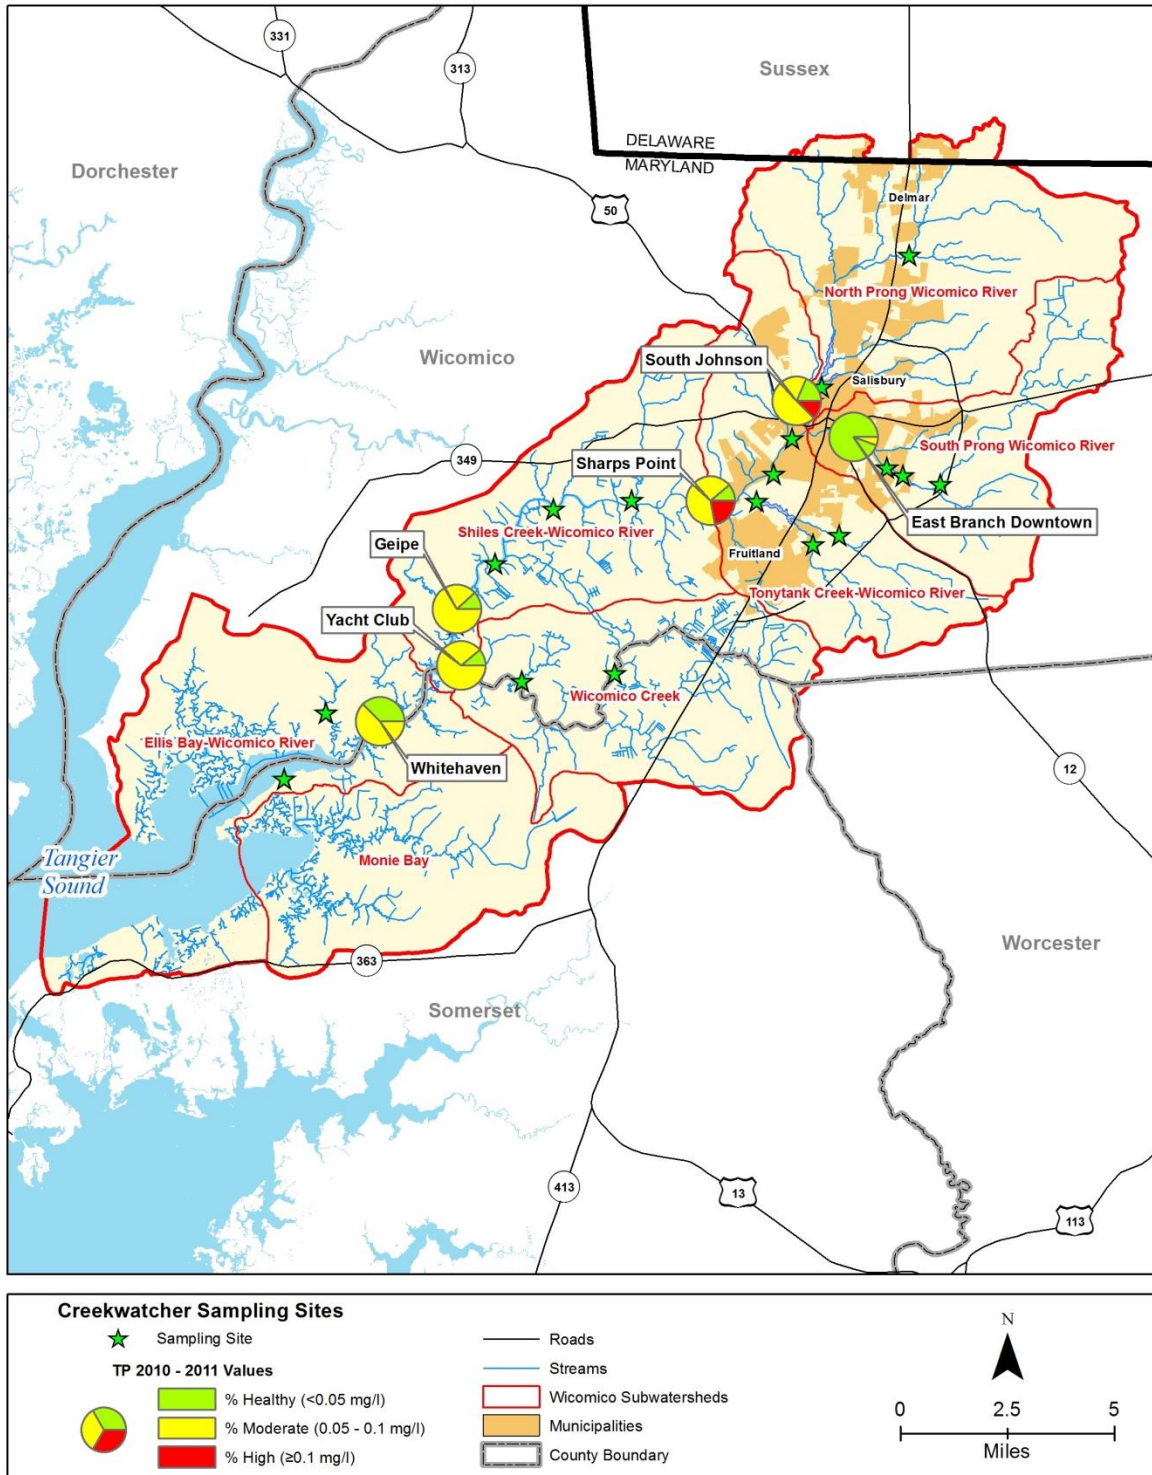
Figure 2. 6. Total Phosphorus Values for Selected Creekwatcher Sampling Sites

Figure 2. 6 and Figure 2. 7 show the locations of the Creekwatcher sample sites. In addition, for the six selected sites, the figures summarize the percent number of samples whose values fall within the water quality thresholds for TP and TN, respectively. The figures show that sites in the headwaters have more samples with a high value threshold. More samples with a healthy value threshold are located in the lower watershed.

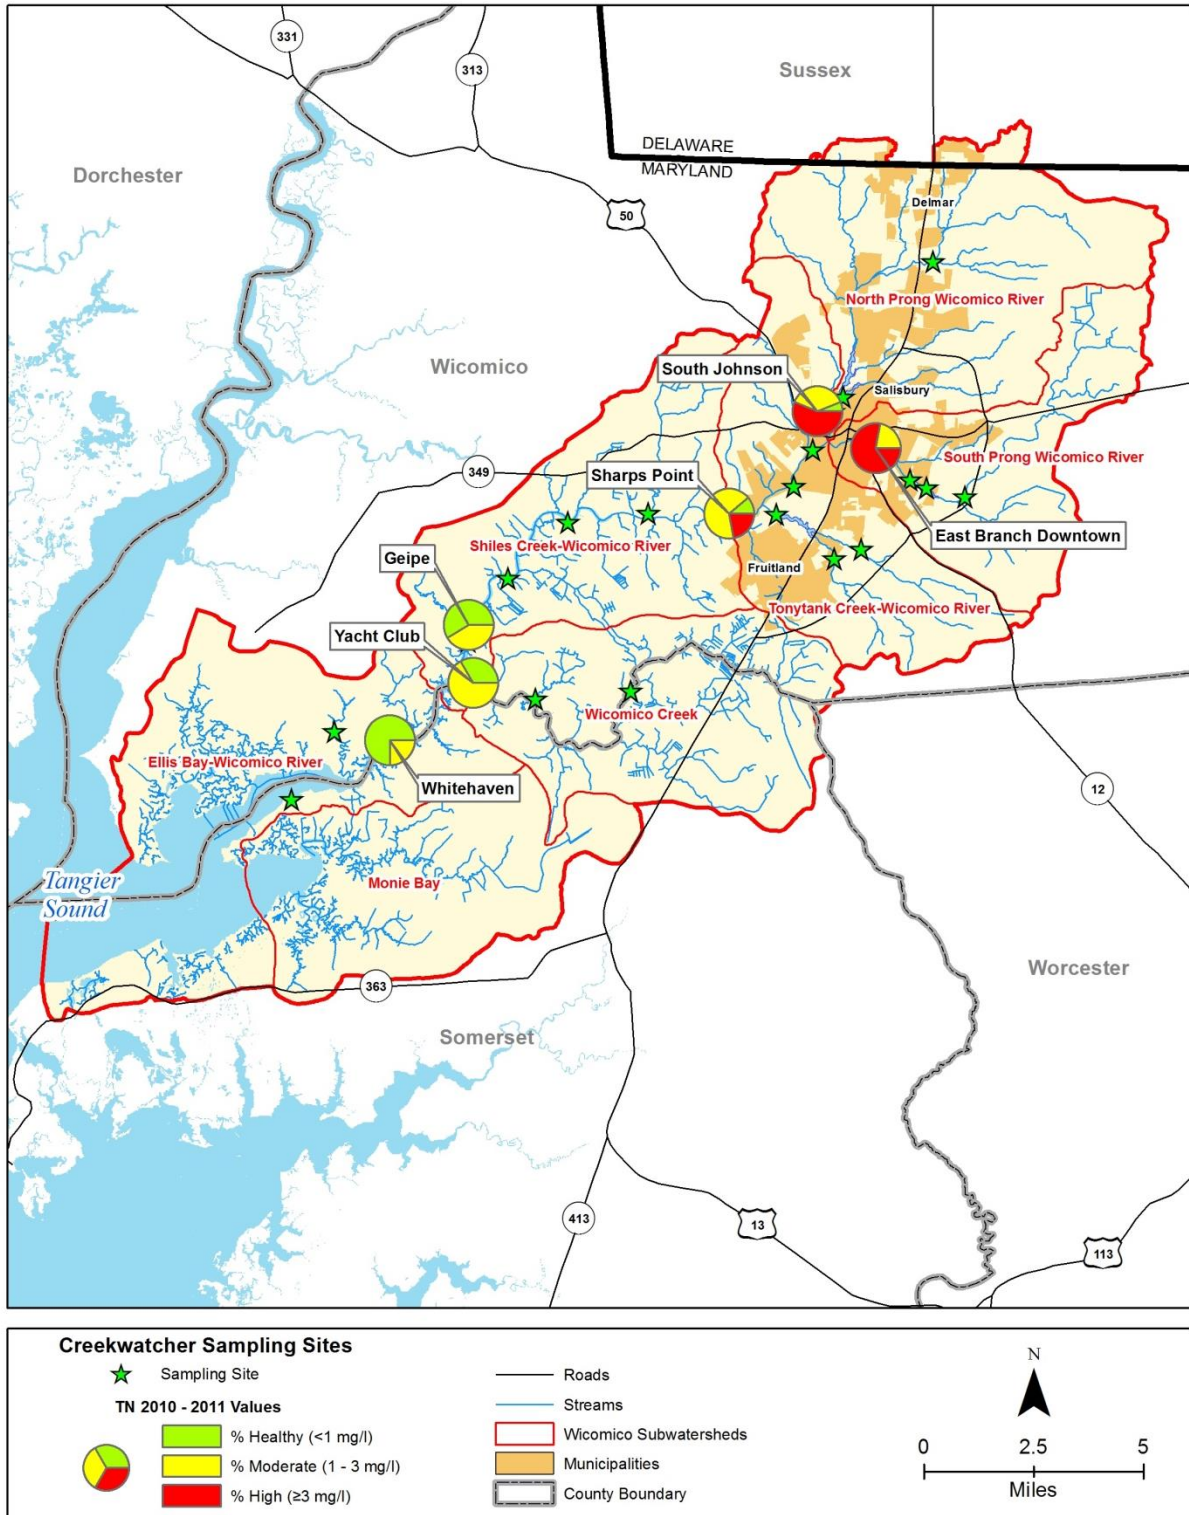
Figure 2. 7. Total Nitrogen Values for Selected Creekwatcher Sampling Sites

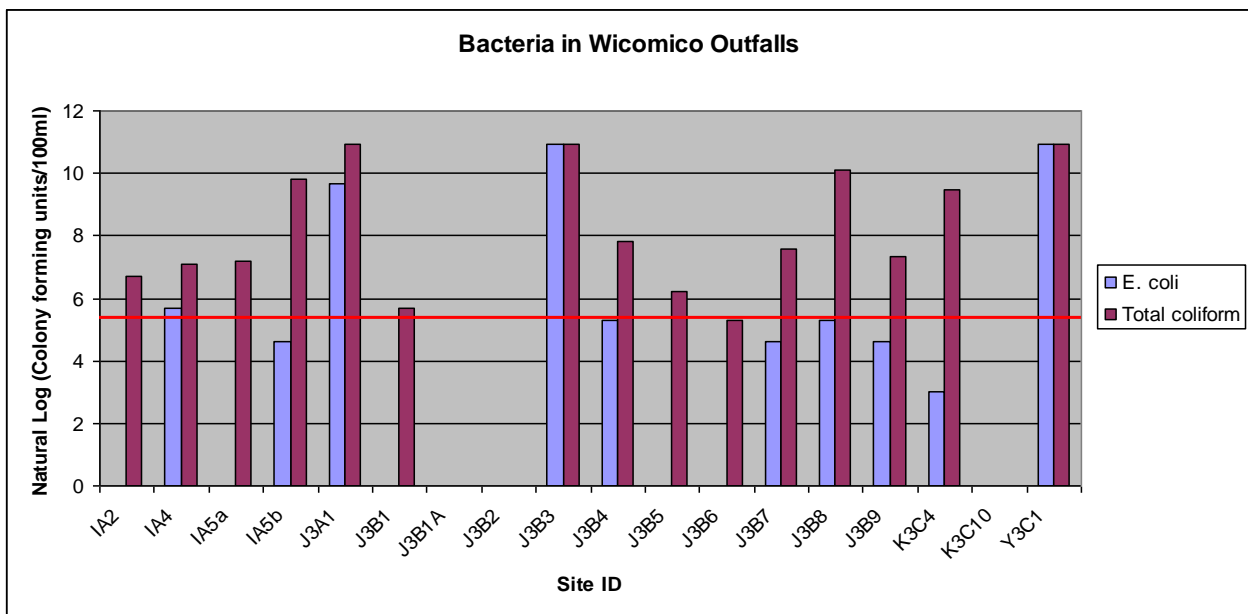
Figure 2. 8. E.coli and Total Coliform Concentrations in Salisbury Outfalls

Illicit discharges are another potential source of bacteria to the watershed. The Center conducted illicit discharge detection and elimination (IDDE) staff training and outfall screening with the City of Salisbury in 2011. The study found 40% of screened outfalls with dry weather flow and 23% of those outfalls with dry weather flow had E. coli concentrations above the EPA’s standard for water contact recreation (235 CFU/100 ml for a grab sample) (CWP, 2011). In addition, very high concentrations of total coliforms were seen in many outfalls as well (Figure 2. 8).

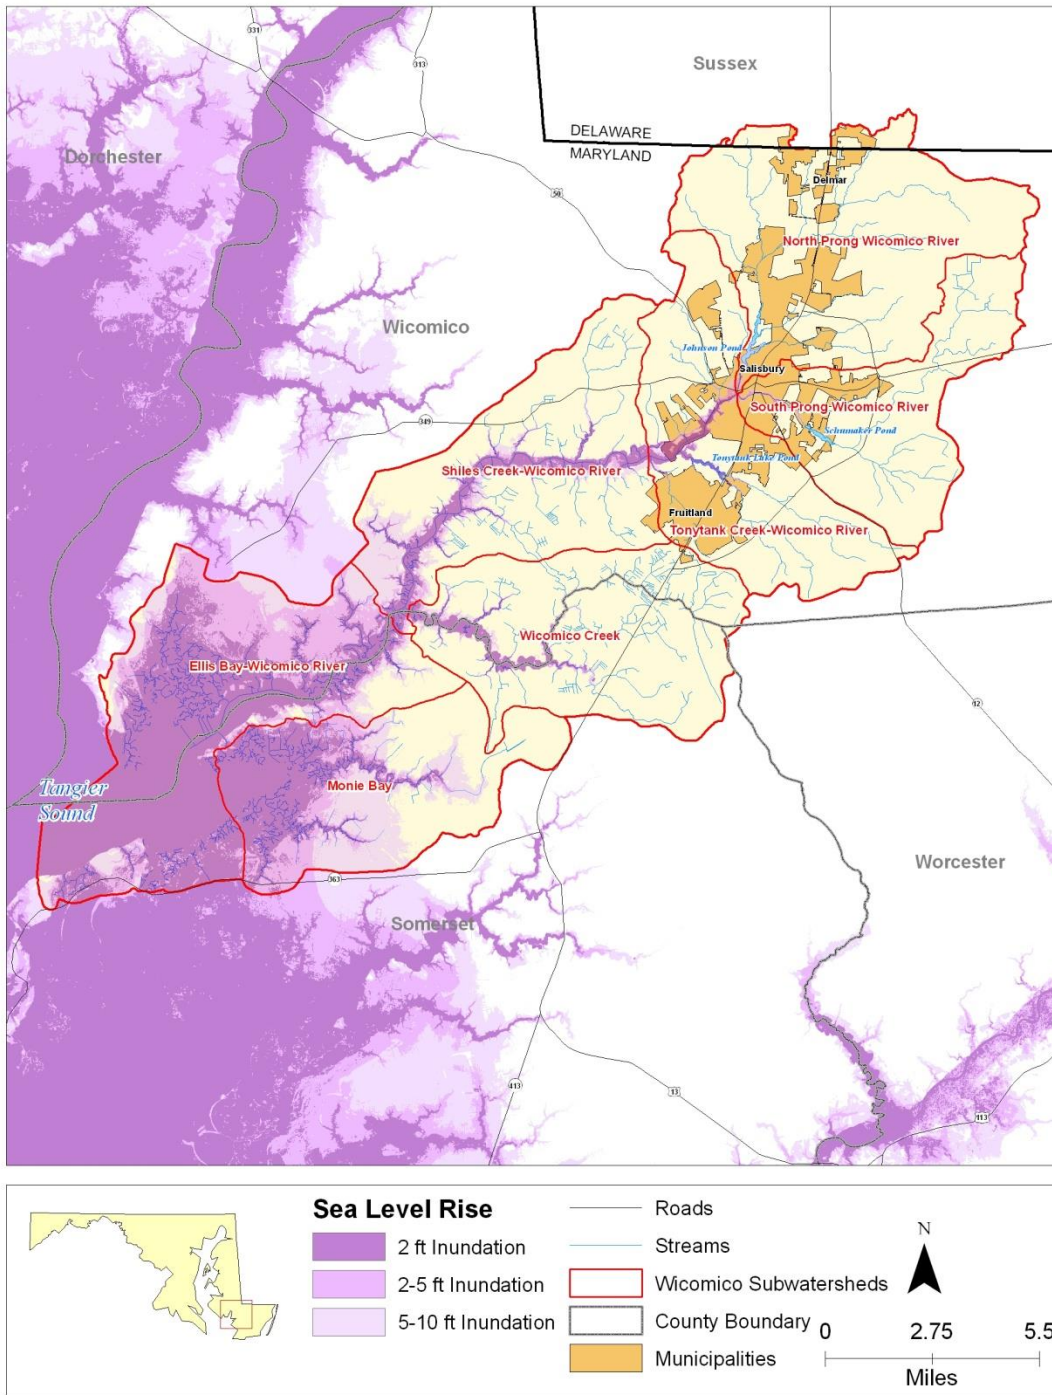
Figure 2. 10. Sea level rise inundation scenarios for the Wicomico River watershed

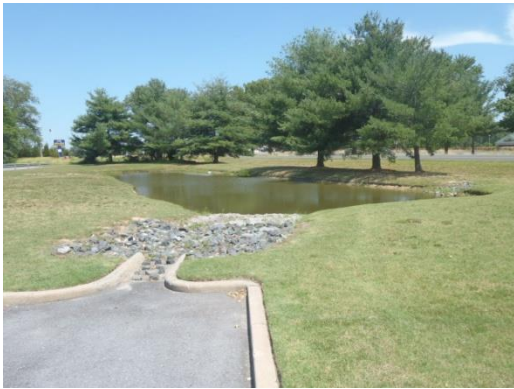
Figure 4. 1. Wet pond with weir outlet structure to road ditch

Several sites inspected as a part of the reconnaissance inventory included existing wet ponds. While some of these wet ponds included an outlet structure that maintains a permanent pool while providing detention capacity for large storms, many did not. These other wet ponds generally had a single weir overflow that directs water to a road ditch or other structure (Figure 4. 1). These types of wet ponds provide less treatment during storm events, and may be difficult to retrofit effectively. It appeared that the outlet structures (usually overflow weirs) did not provide any significant restriction of flow, especially for smaller storm events, such as the 2-year storm. If the ponds are not providing detention of storm events, they still have a water quality benefit, but not as much as if detention were provided.

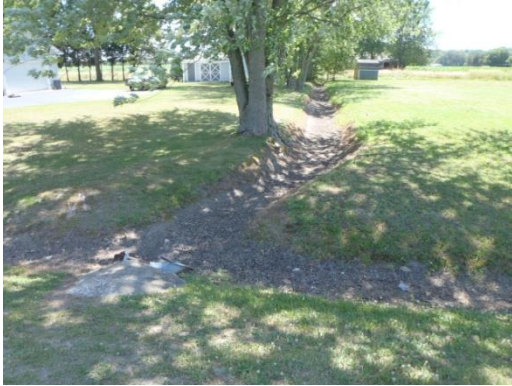
Figure 4. 3. Opportunity for ditch restoration in SP_NSA_6.

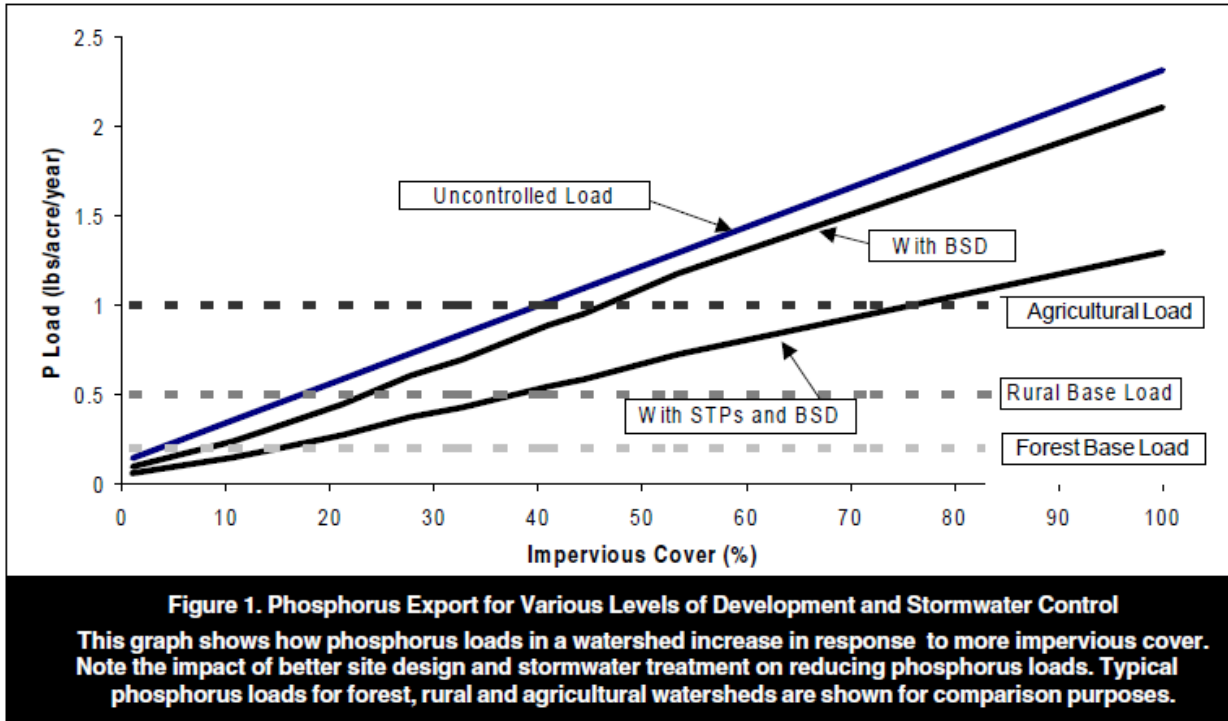
Figure 4. 4. Better site design and stormwater treatment reduce phosphorus loading (Caraco, 2001)

Regarding the lakes in South Prong, Tony Tank and North Prong Subwatersheds, managers should study the ecological factors that sustain and reinforce dense populations of aquatic weeds. Lake managers may need to resort to in-lake treatment practices such as harvesting, dredging, water level manipulations or applications of herbicides. These practices often need to be combined with emerging “biomanipulation” practices, and the more traditional watershed treatment practices that can reduce phosphorus inputs to lake sediments (Schueler and Simpson, 2001). Better site design and implementation of stormwater treatment practices will also reduce phosphorus loading (see Figure 4. 4).

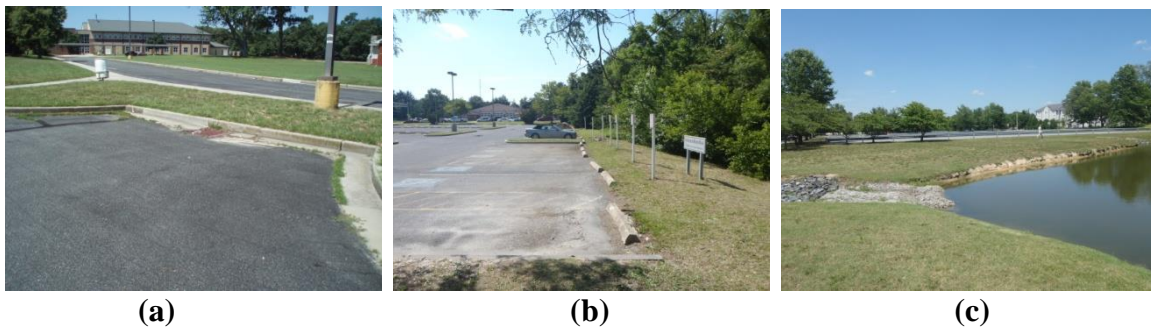
Figure 4. 6. (a) Bioretention opportunity at SP_RRI_15A; (b) sediment build-up in Ward Museum parking lot (SP_RRI_305A); and (c) existing wet pond at SP_RRI_17 could be retrofit to provide additional water quality treatment

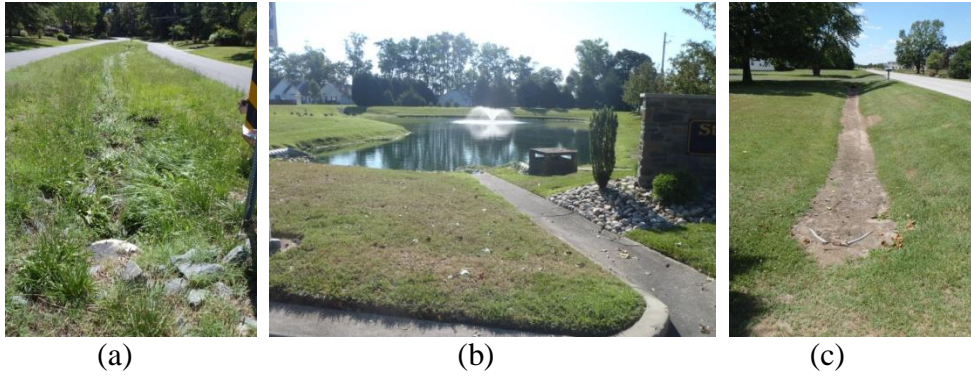
Figure 4. 7. (a) Opportunity for stormwater treatment at SP_NSA_15; (b) Opportunity for tree planting around a stormwater pond at SP_NSA_5; and (c) Opportunity for ditch restoration at SP_NSA_6

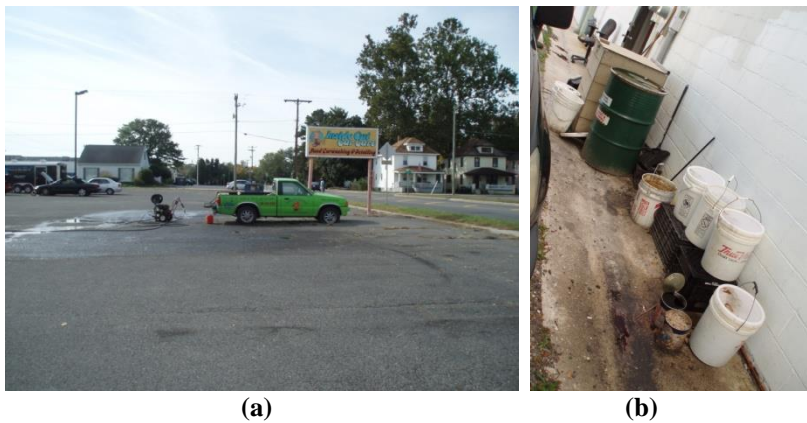
Figure 4. 8. (a) Commercial vehicle washing on impervious cover (HSI_20a) and (b) improperly stored materials (HSI_20b)

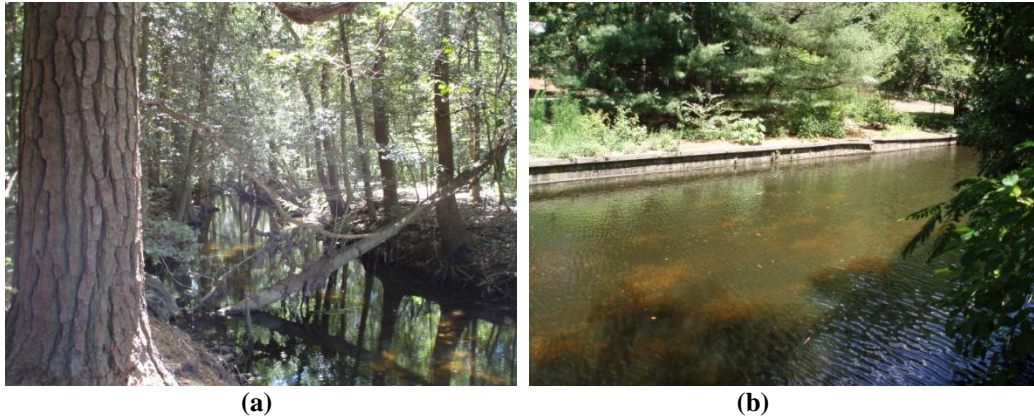
Figure 4. 9. (a) RCH 13 - "excellent reach" and (b) channelized section of RCH4 - "poor" reach

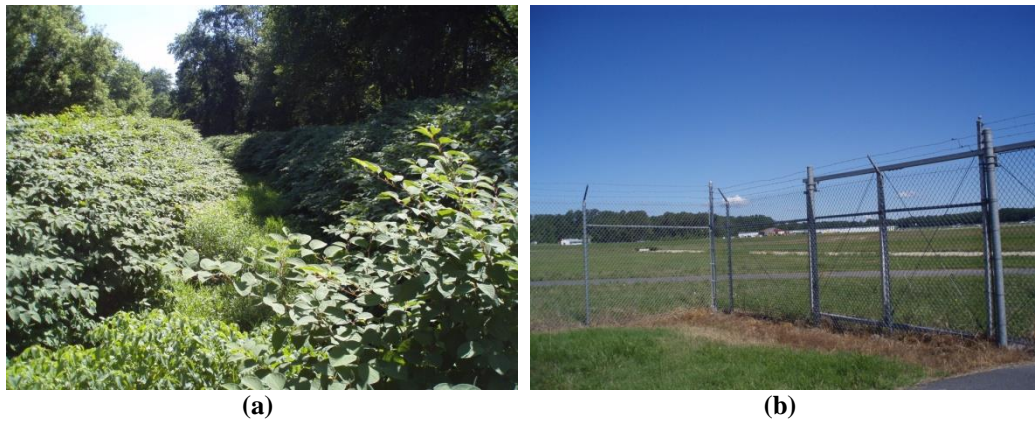
Figure 4. 10. (a) Impacted buffer (IBI 701) has been overrun with invasive Japanese knotweed and (b) channel modification (CM 3101) at the airport

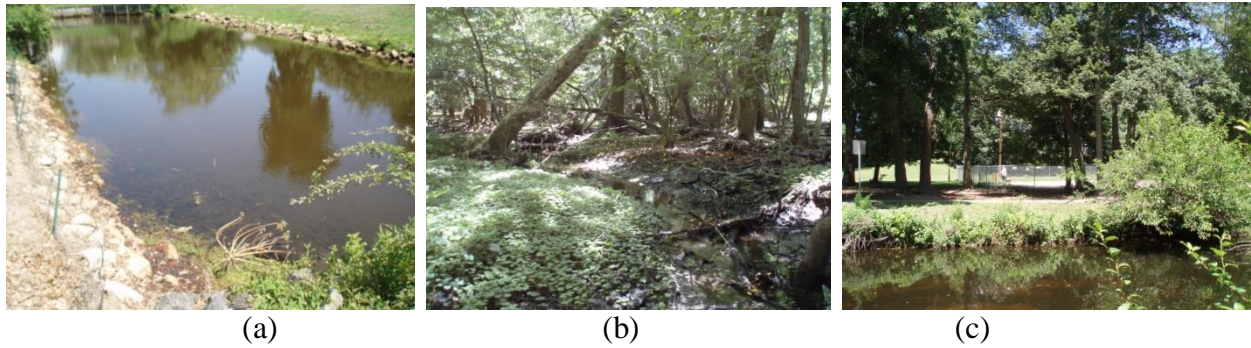
Figure 4. 11. (a) Very poor stream reach with no buffer and hardened banks (SP_RCH_8); (b) Excellent stream reach with floodplain access and good buffer (SP_RCH_33); and (c) Opportunity for buffer enhancement (SP_IB_501)

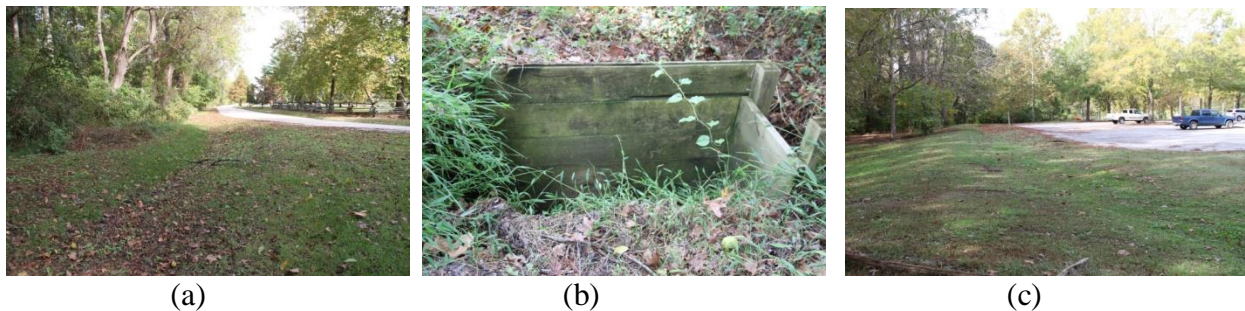
Figure 4. 14. (a) Location for regenerative stormwater conveyance at RRI_41a; (b) wooden box pipe to be removed at RRI_41a; (c) location for bioretention facility to treat parking lot runoff at RRI_41b

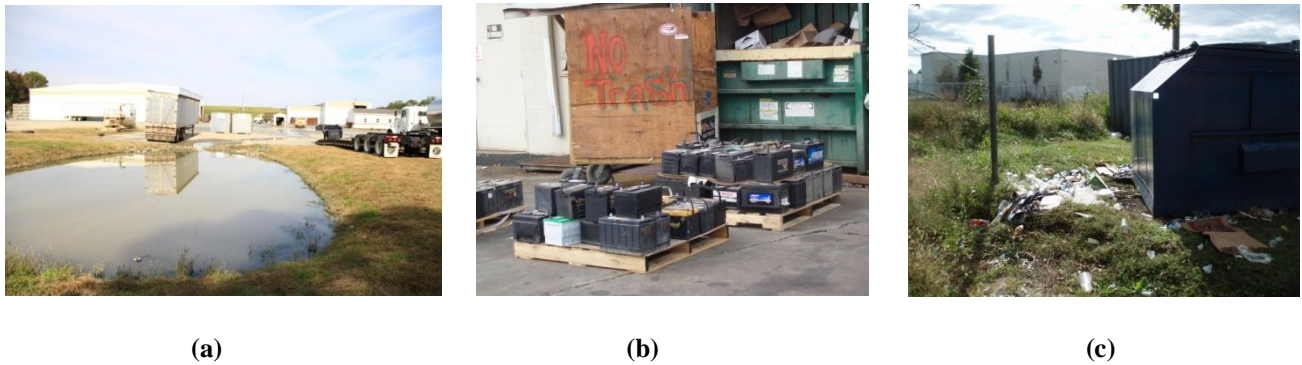
Figure 4. 16. (a) Municipal vehicle washing on impervious surface (TT_HSI_67); (b) batteries stored outside without cover or containment (TT_HSI_22b); and (c) poor trash management (TT_HSI_22a)

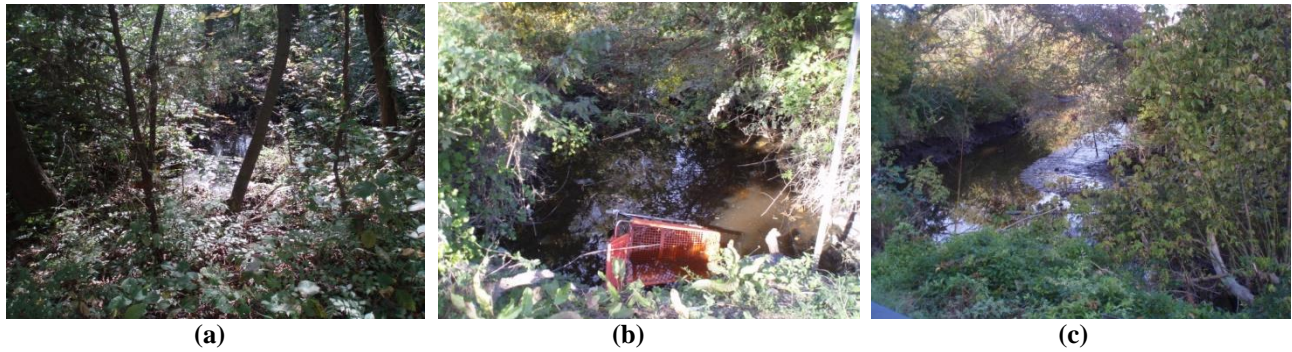
Figure 4. 17. (a) RCH_33 - "excellent reach;" (b) trash in RCH_37 - "poor" reach; and (c) "fair" tidal RCH_26

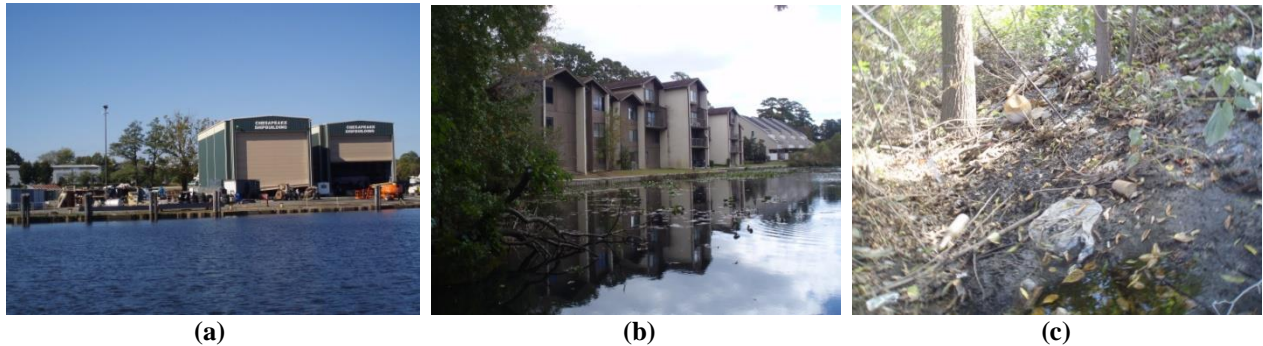
Figure 4. 18. (a) Hotspot operation and impacted buffer (IB46-1); (b) impacted buffer in Canal Woods development (IBI3_1) and (c) opportunity to engage local neighbors in a volunteer trash clean-up (TR36_1)

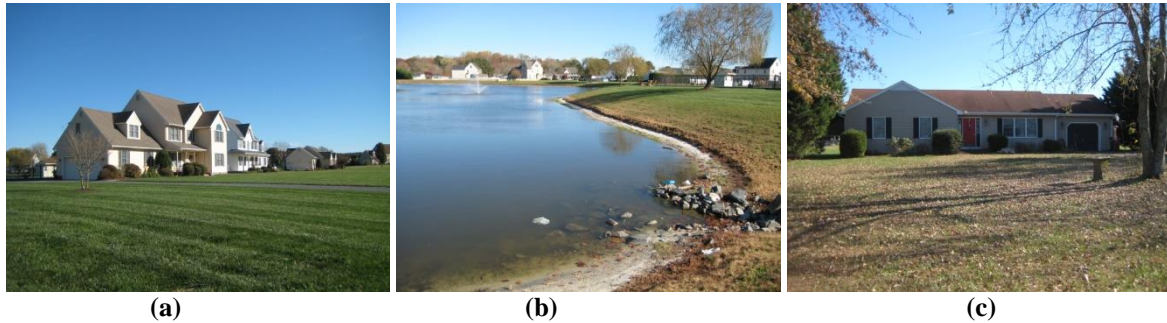
Figure 4.21. (a) High pollution severity as evidenced by a highly managed lawn at NP_NSA_19a; (b) Stormwater pond at NP_NSA_20 with opportunity for vegetated buffer, pond retrofit and floating wetlands to improve water quality; and (c) Opportunity for rain gardens at NP_NSA_19b.

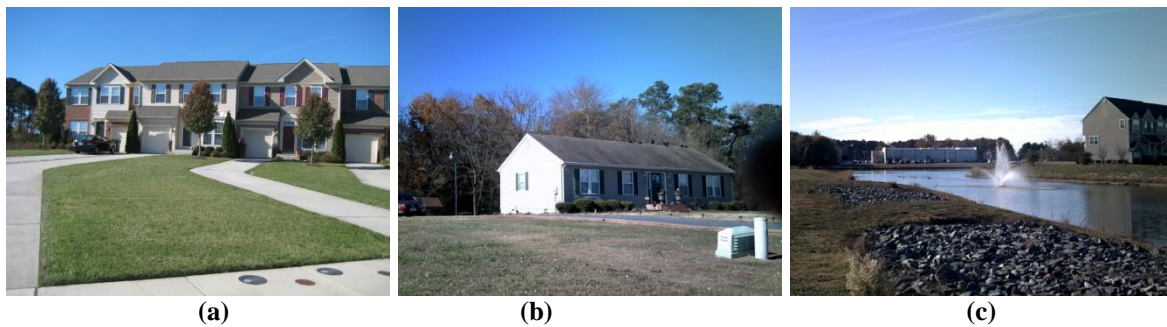
Figure 4.22. (a) Highly manicured lawn at NP_NSA_21 with high pollution severity and little available space for restoration; (b) Lots with little tree canopy at NP_NSA_8; and (c) Stormwater pond mowed to edge at NP_NSA_10.

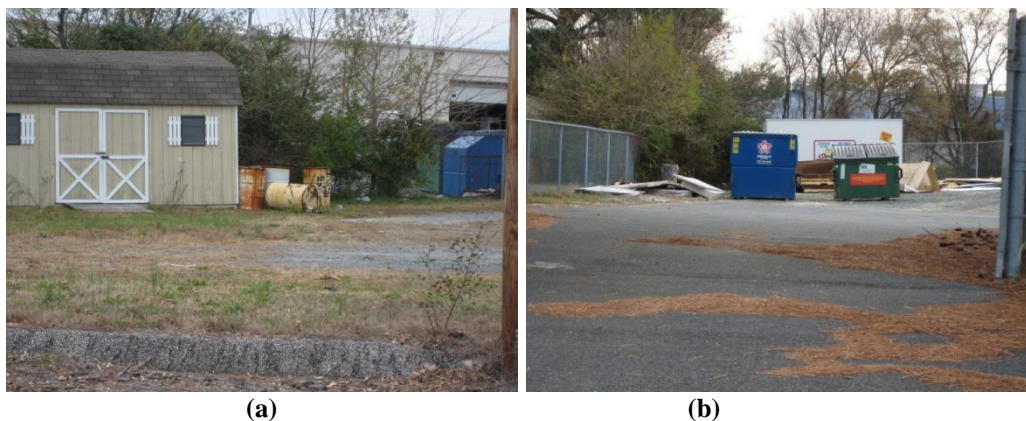
Figure 4.23. HSI_30 (a) 55-gallon unlabeled drums, rusting and knocked over at Line X and (b) Raw materials and trash strewn about behind the commercial property at the southeast corner of Northwood Drive and Alexander Avenue.

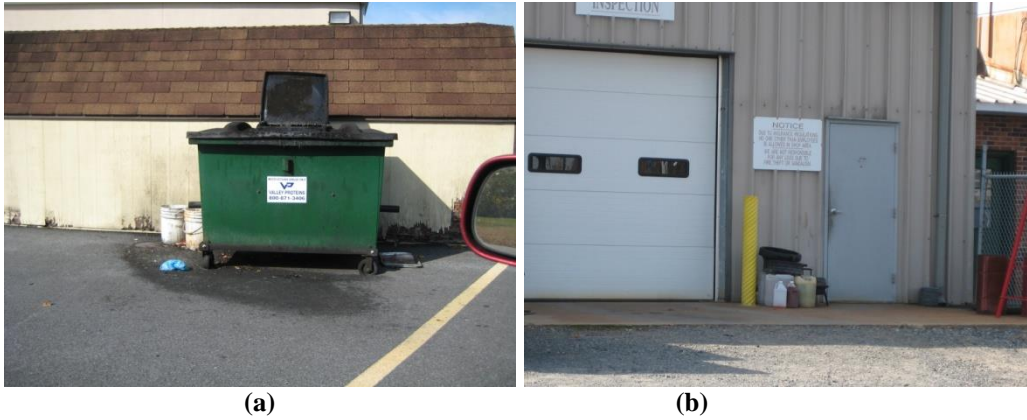
Figure 4.24. HSI_10 (a) Restaurant grease container at Mr. Pauls, open with stains all around and (b) Chemicals in unlabeled containers outside without cover or containment at Boulevard Motors.

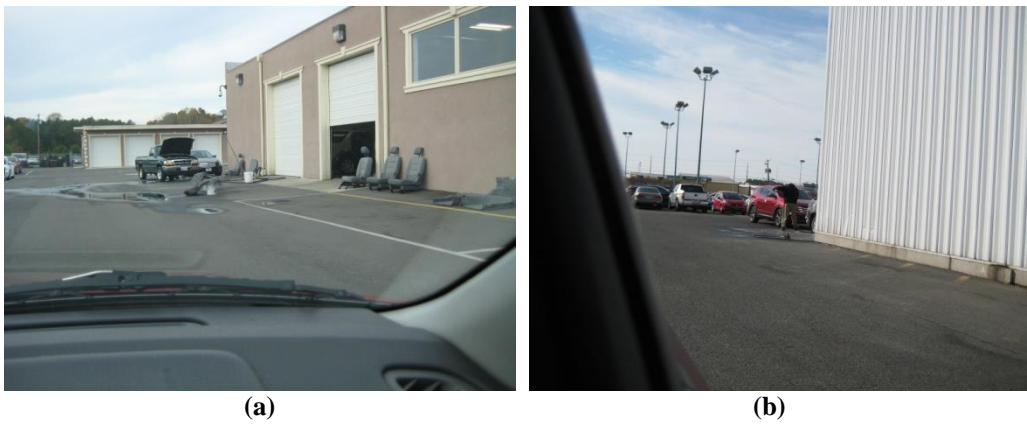
Figure 4.25. Outdoor vehicle washing at (a) Sherwood of Salisbury (HSI_14) and (b) Pohanka of Salisbury (HSI_15a).

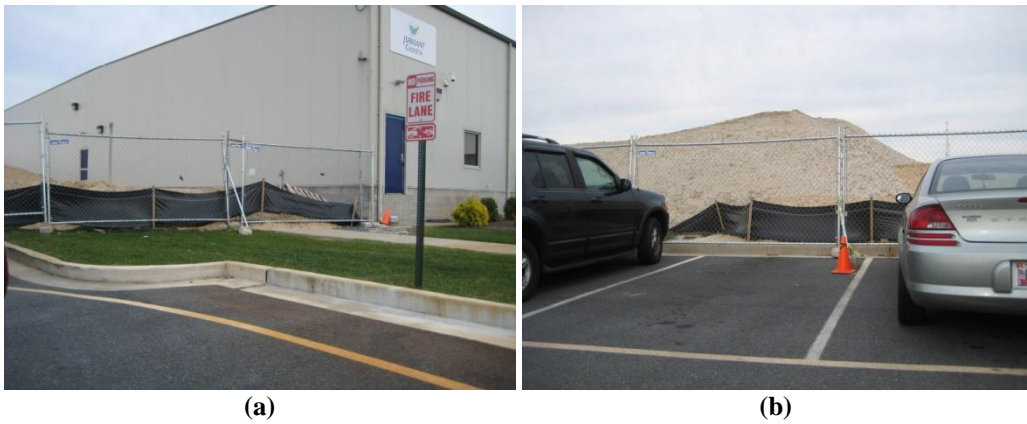
Figure 4.26. HSI_31 (a) and (b) Poor erosion and sediment control (ESC) practices at Jubilant Cadista.

- HSI_31, Jubilant Cadista, Kiley Dr. (Figure 4.26): Poor erosion and sediment control practices.

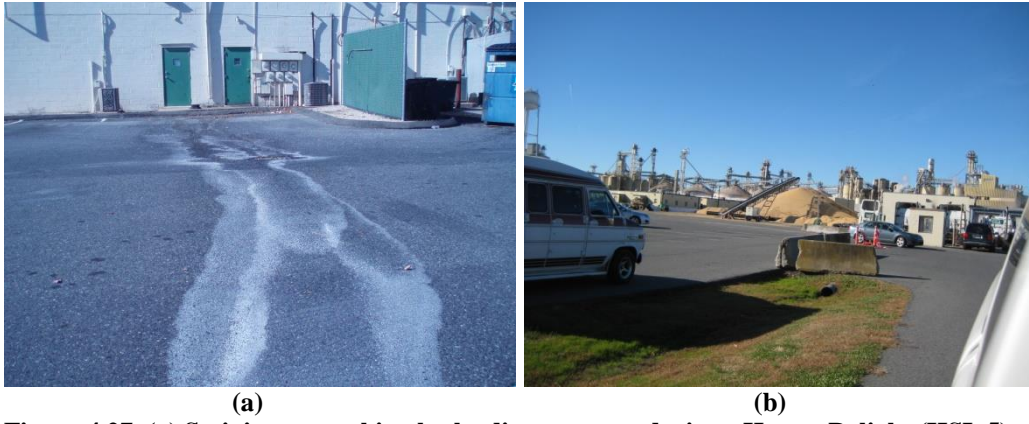
(a)
Figure 4.27. (a) Staining on parking lot leading to storm drain at Hunan Delight (HSI_5) and (b) Raw materials stored outside without cover at the Perdue plant (HSI_12).

- HSI_5, Hunan Delight, 901 N. Salisbury Blvd (Figure 4.27a): Staining on lot to storm drain from mop water dumping.
- HSI_12, Perdue plant (Figure 4.27b): Site could not be accessed. Large piles of grain stored outside but drainage uncertain.

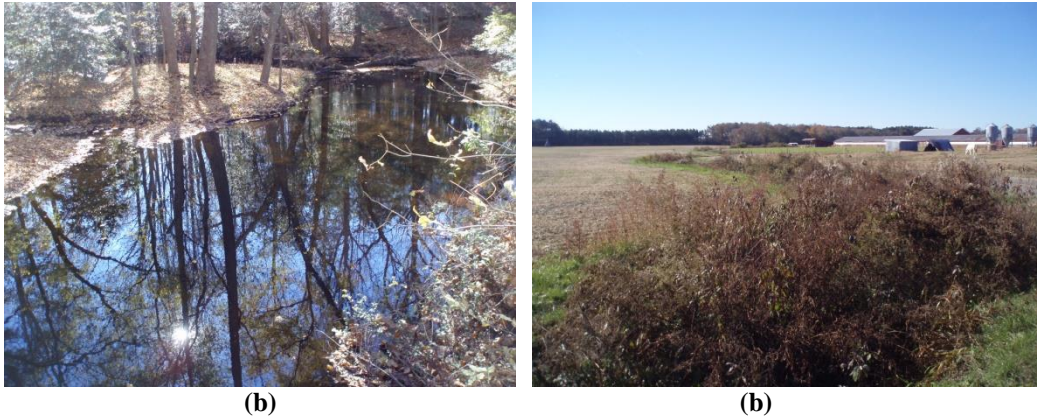
Figure 4. 28. (a) RCH 101a - "excellent reach" with wide, forested buffer and good floodplain connectivity and (b) RCH 104 - "very poor" reach in the headwaters modified as a drainage ditch.

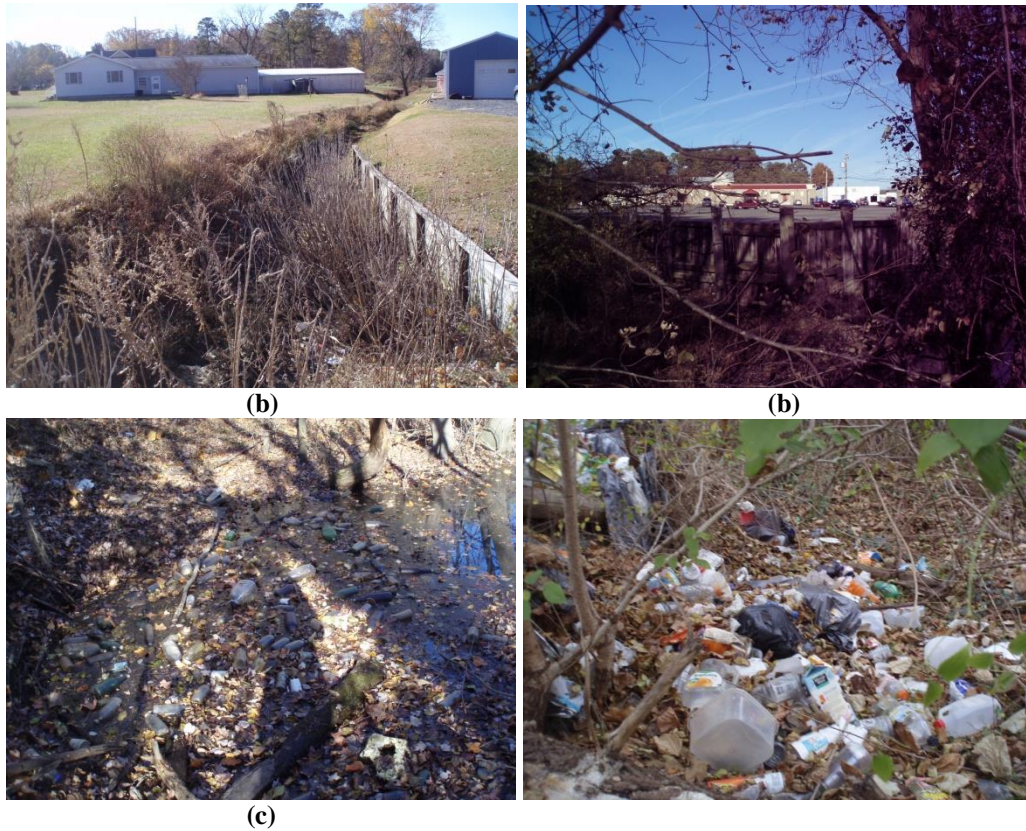
Figure 4. 29. (a) Headwater stream modified as tax ditch (IB105_2); (b) impervious lot to edge of stream (IB204_1); (c) Trash accumulation at TR113a_1; and (d) Dumping at TR304_1.
